Dear A+E Networks Affiliate,

In anticipation of possible rule making by the FCC to expand the use of the Video Descriptive Service (VDS) to more networks, we have recently added additional audio PIDs to all our services to ensure we have a second audio service available.

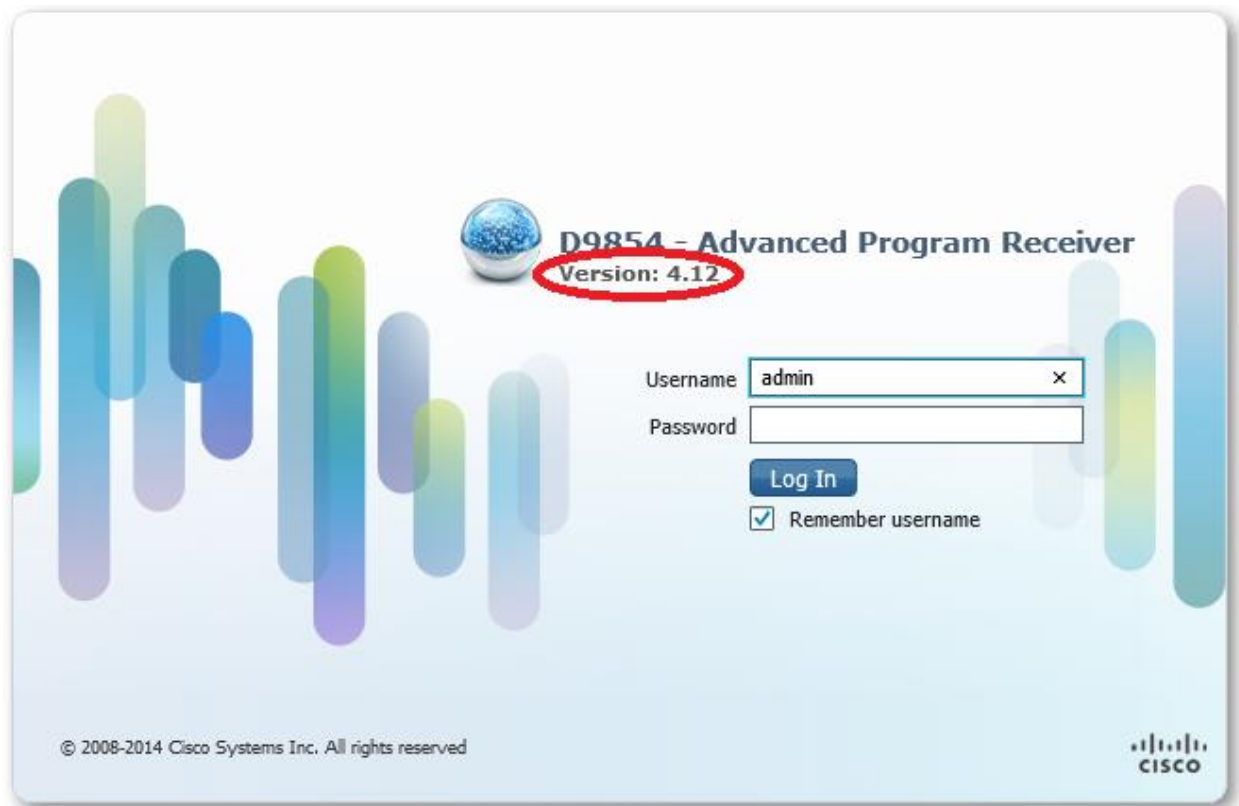
The App Code version you are currently running can be found on the login screen of your IRD.

To login to your IRD, open a browser (Google Chrome is preferred) and go to Default IP Address: 192.131.244.6. The Username is “admin” and the Password is “localadmin”.

An example of a D9854 is shown below.
